The Corbit-Sharp House at Odessa, Delaware: Finishes Analysis and Interpretation of Four Interior Rooms

Catherine Ruth Matsen
University of Pennsylvania

THE CORBIT-SHARP HOUSE AT ODESSA, DELAWARE:
FINISHES ANALYSIS AND INTERPRETATION OF FOUR INTERIOR ROOMS

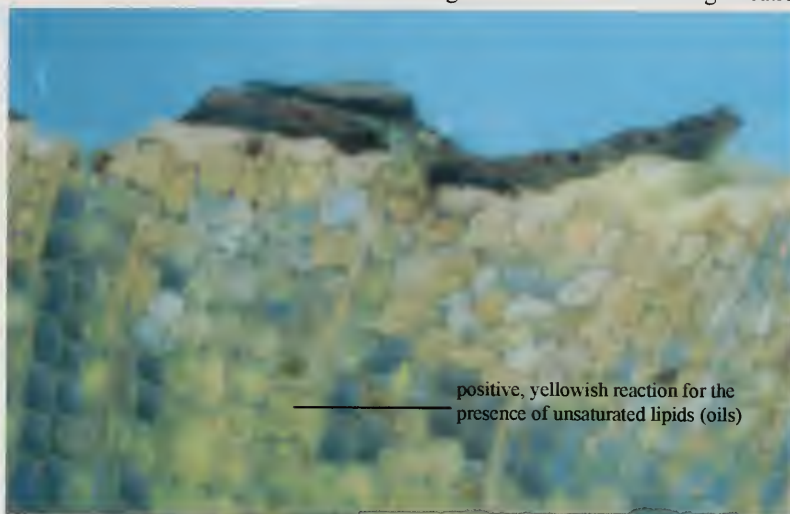
Figure F-7c.

Sample 13
DCF

parlor, baseboard
ultraviolet light

125X magnification

Fluorescent staining of sample 13 (from the baseboard) suggests the presence of oil within the wood substrate. These samples show a positive reaction to DCF for the presence of unsaturated lipids as indicated by a bright yellow reaction color in reflected ultraviolet light (Figure F-7c., sample 13).

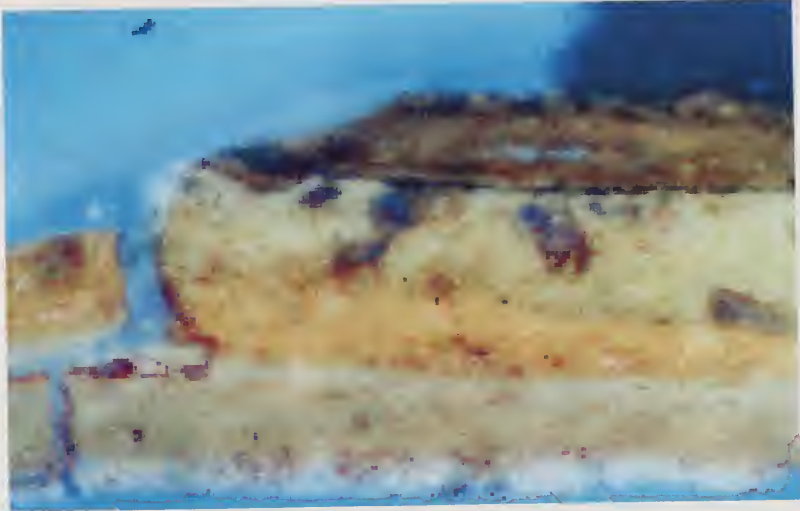
Figure F-11c. Sample 100 parlor, plaster wall
TTC ultraviolet light 125X magnification

Sample 100 from the plaster wall was stained with TTC to test for the presence of carbohydrates (Figures F-10c. and F-11c., sample 100). Wallpaper paste residue, usually in the form of a wheat starch paste, is a carbohydrate-based material. In cross-sections where wallpaper is known to have existed, the positive deep red reaction color for the presence of starch paste is usually seen as a thin line below the paper surface. Starch paste that penetrates cracks within the substrate or earlier finish layers will also produce a red reaction when exposed to TTC. While positive reactions for the presence of carbohydrates are apparent in the cross-section, the pattern of staining does not provide compelling evidence for the presence of wallpaper paste above the limewash. This analysis does not definitively conclude that the walls of the parlor were not wallpapered in the first generation. One can only say that conclusive evidence of a wallpaper treatment was not found in the sample analyzed.

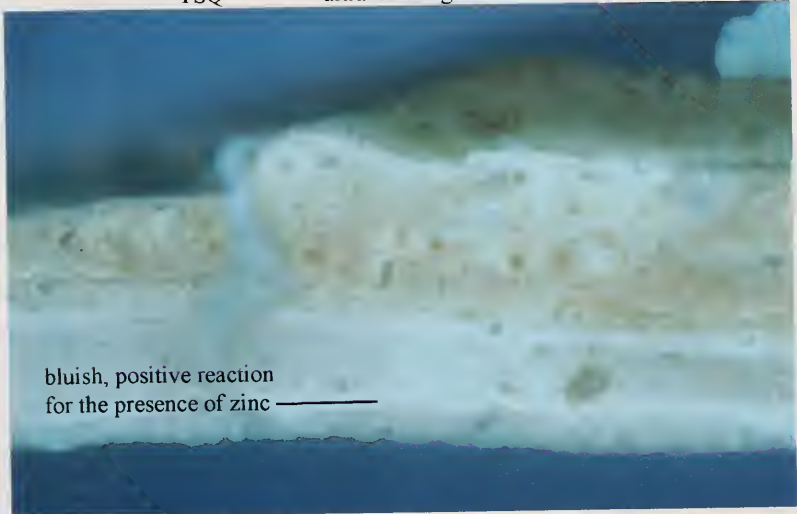
Figure F-11d. Sample 100 parlor, plaster wall
TSQ ultraviolet light 125X magnification

The paint above the plaster substrate of sample 100 was stained with TSQ to test for the

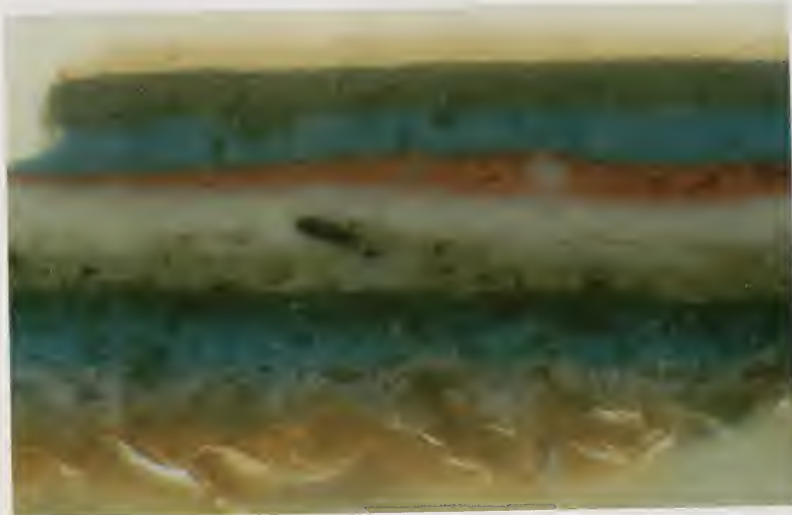
Figure F-24a. Sample 69 first-floor northwest chamber, window panel
reflected visible light 250X magnification

Sample 69, from the side panel of the right window, is a piece of restoration woodwork. The cross-section photomicrograph shows a different first-generation paint scheme (gray primer with blue finish coat) while the successive layers match those found on the other restoration woodwork samples (Figure F-24, sample 69). The restoration woodwork is therefore collected from a variety of sources of “old material”.

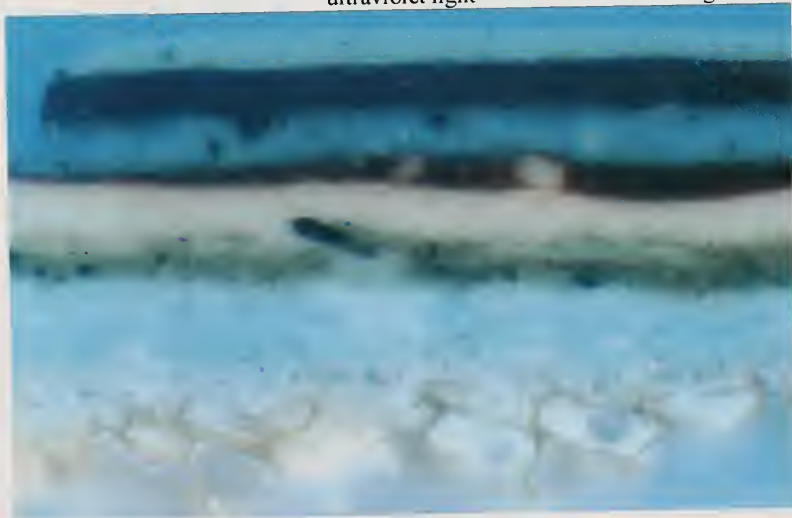
Figure F-24b. Sample 69 first-floor northwest chamber, window panel
ultraviolet light 250X magnification

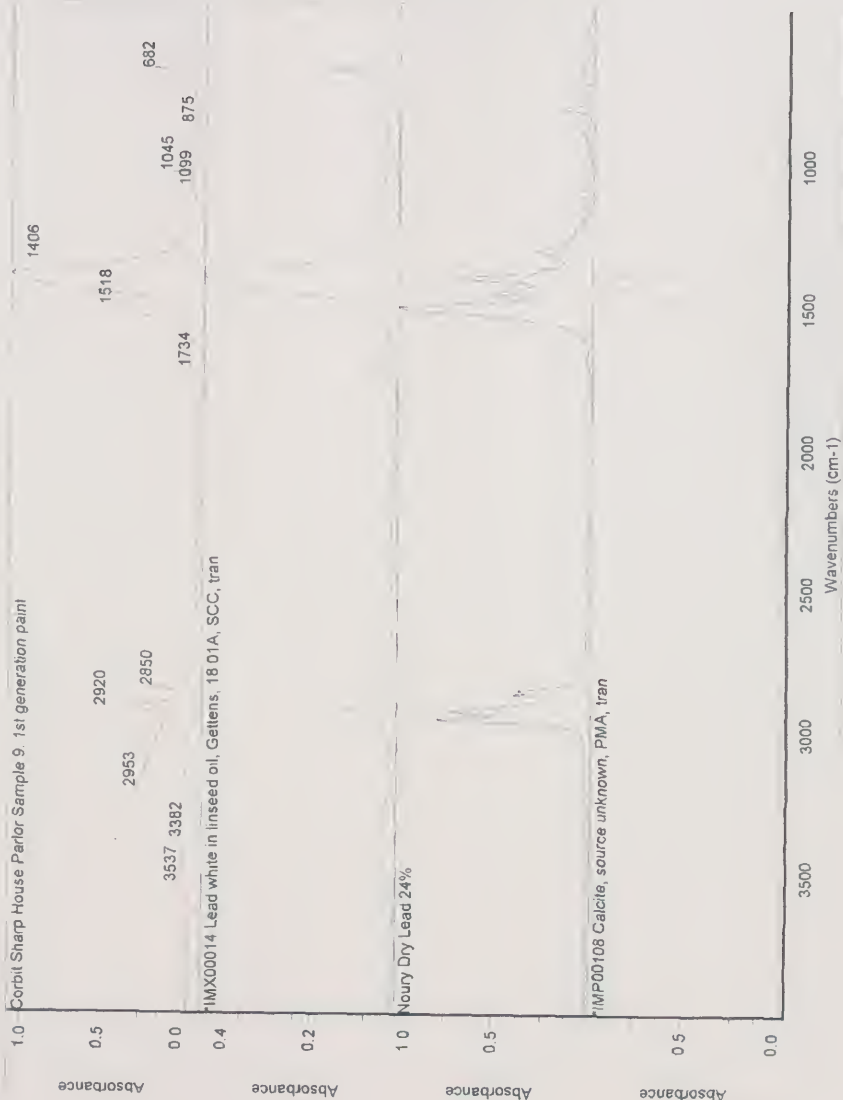
Sample 9
FTIR spectrum

parlor, surbase
first generation paint

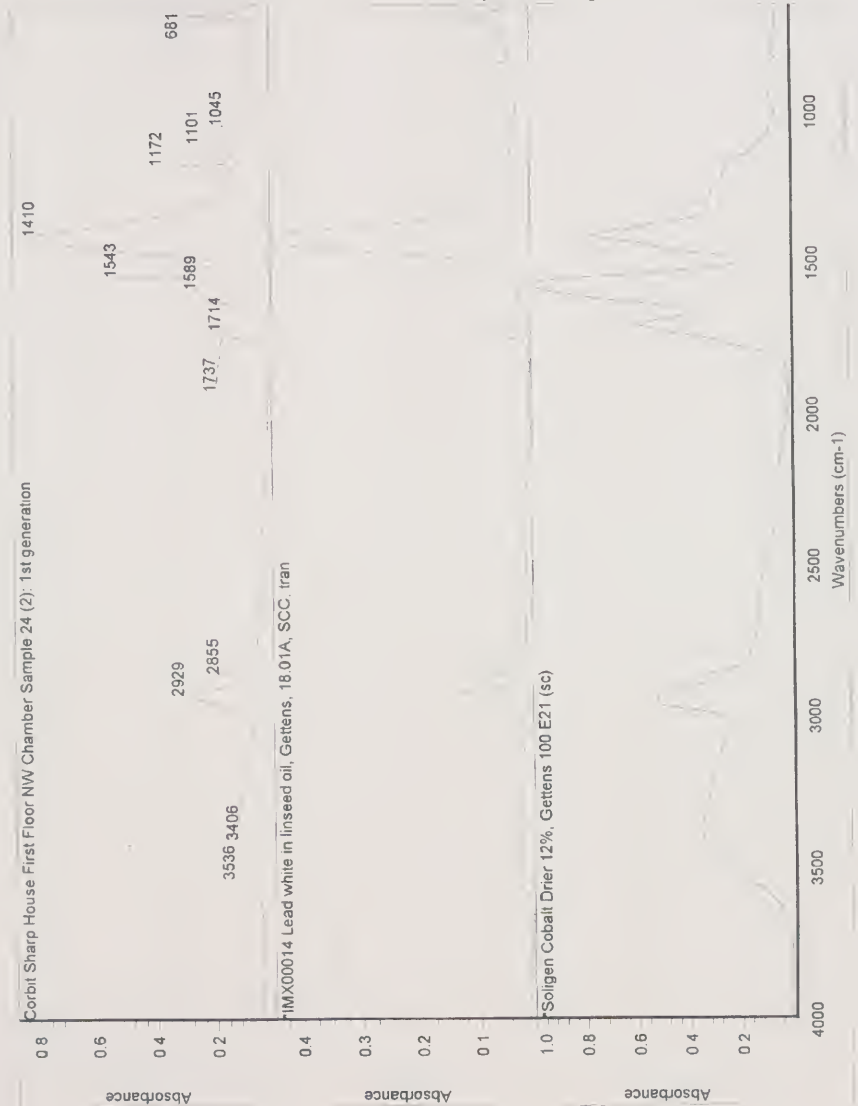
Figure H-6a.

Sample 24
FTIR spectrum

first-floor northwest chamber, closet door
first-generation green finish

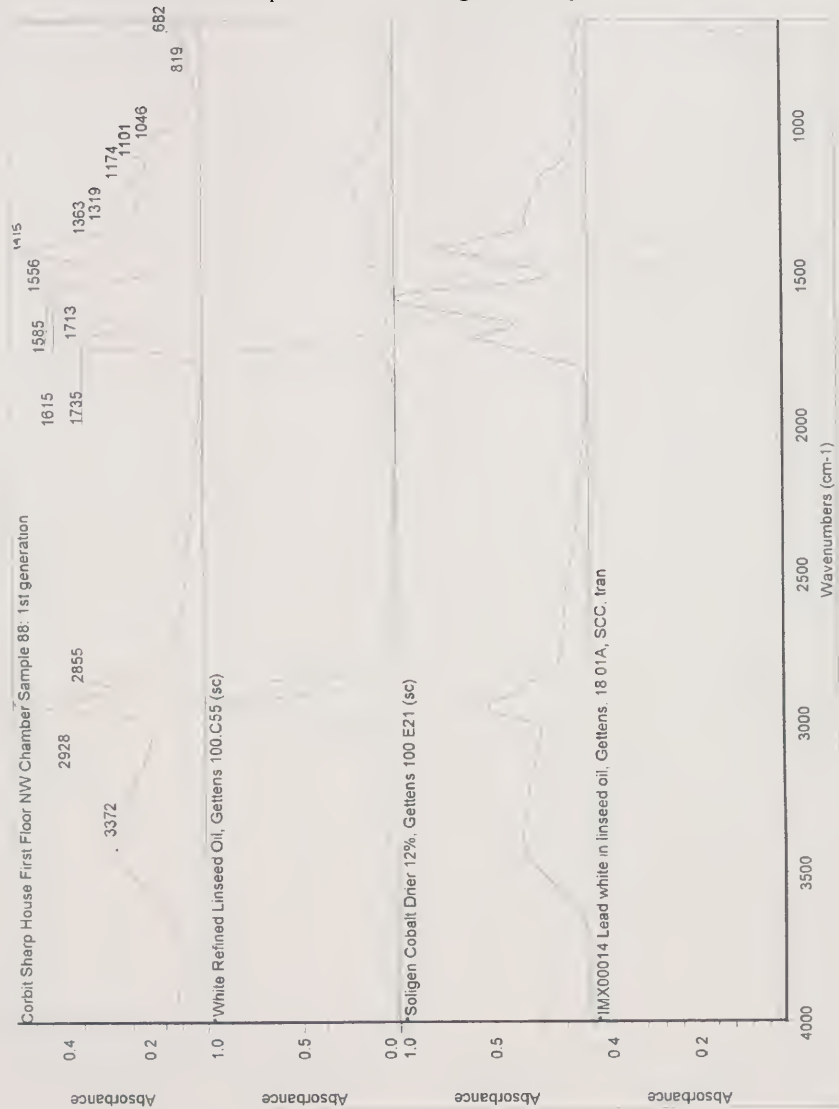
Figure H-7a.

Sample 88
FTIR spectrum

first-floor northwest chamber, door architrave
first-generation green finish

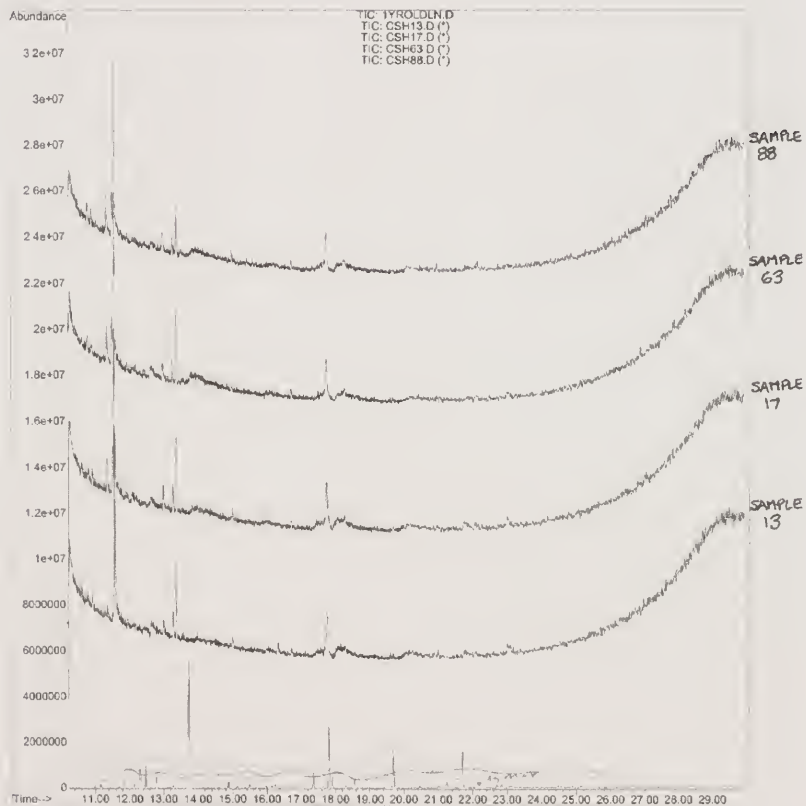
Samples 13, 17 and 63
GC chromatogram

GC-MS analyses were performed on samples 13, 17, and 63 in order to more accurately determine the paint binding media as compared to the information provided by cross-section fluorescent staining and FTIR analyses. For samples 13 and 63, from the parlor base and wainscot, respectively, the composition of the original finishes was analyzed; for sample 17, the fifth generation white paint was analyzed. FTIR analysis of the fifth generation paint indicates an oil-based binding media while fluorescent staining tests positive for the presence of proteins and carbohydrates; this data suggests the presence of an emulsion paint. Unfortunately, GC chromatograms and MS spectra of the three samples did not yield identifiable peaks and thus the results are inconclusive (Figure J-1).

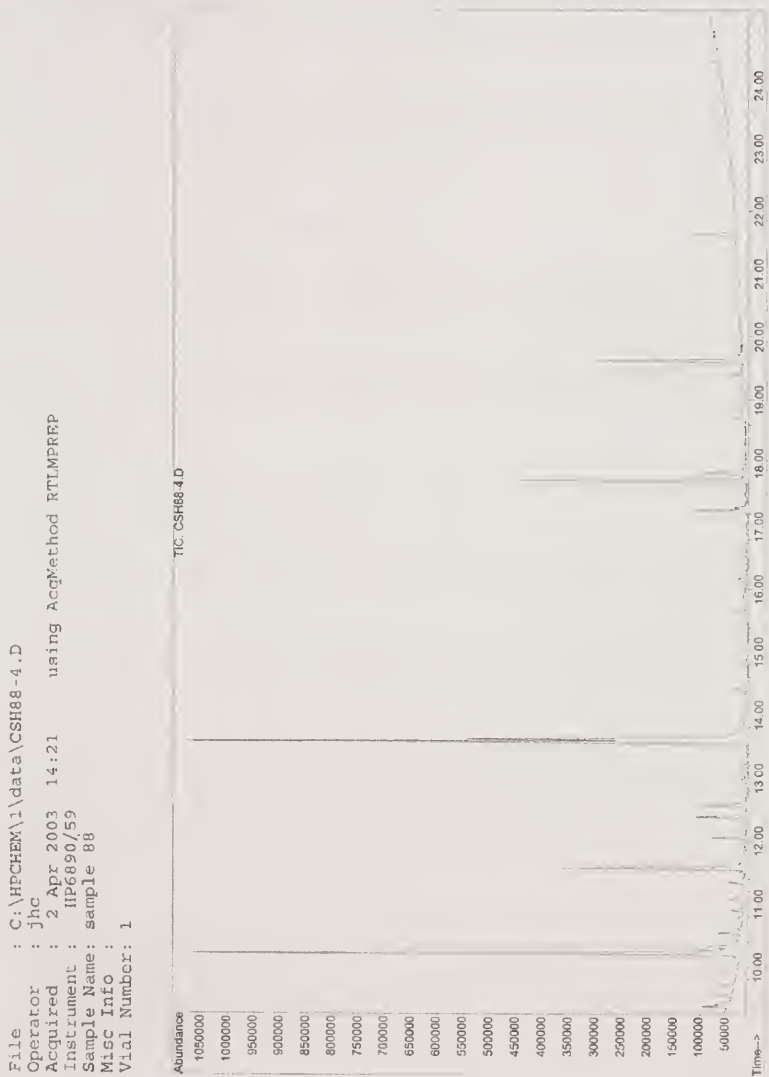
Figure J-2

Sample 88 first-generation, green finish
GC chromatogram
